Township of Haverford

Master Plan

**Report of the Property Committee
Of the Haverford Township Board of Commissioners**

June 13, 2011

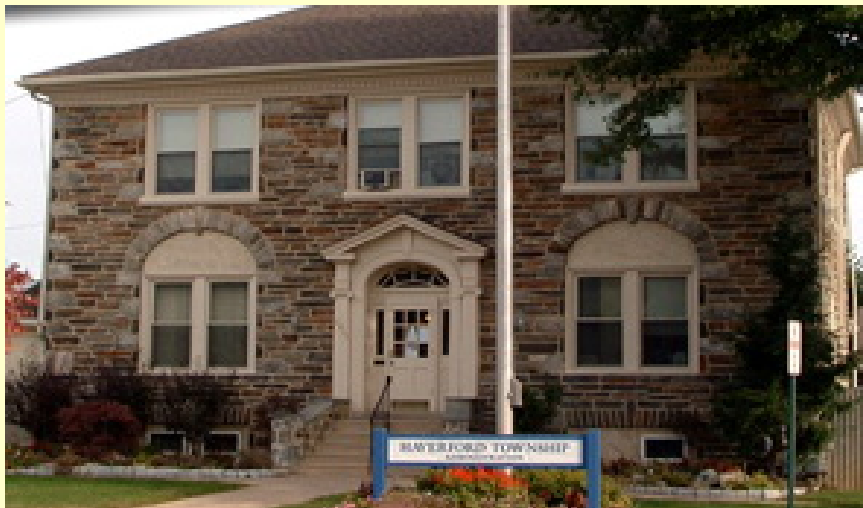
There are structural cracks running from the first to the second stories, starting at or above the first floor windows on the east side of the building. There is also evidence that some areas were constructed with undersized foundation supports (in the lobby and the drive-through window extension) where there are settlement cracks and groundwater infiltration into the building.

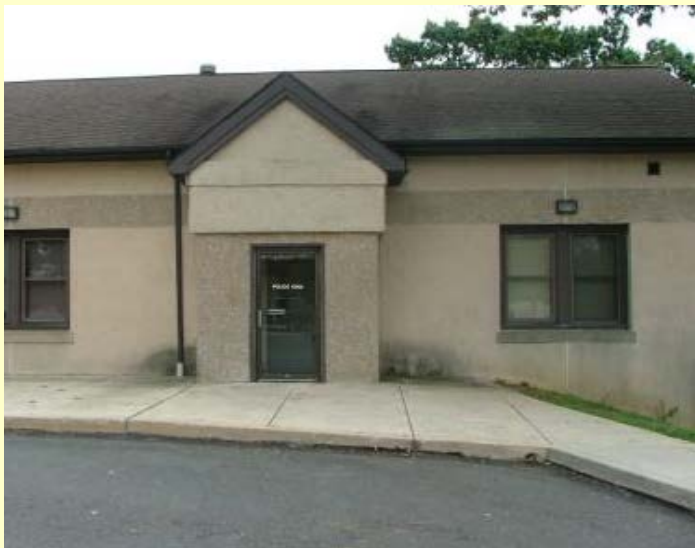
The current Police Station is also over 50 years old. It is located at Veterans Field, Manoa and Darby Roads. Garages on the lower floor have been converted to offices, and the most recent renovation has, for the first time, provided an internal access between the floors by means of a spiral staircase. The building contains approximately 6,200 square feet of gross floor area.

Since the 1988 plan, the Township added an ADA compliant ramp to access the upper level lobby, radio room and managerial offices at the Police Station. However, that addition, while relieving some of the overcrowding by increasing the size of the facility to approximately 11,000 square feet, did little to address the functionality including the lack of halls, stairs and/or an elevator to make the various parts of the building accessible to one another.

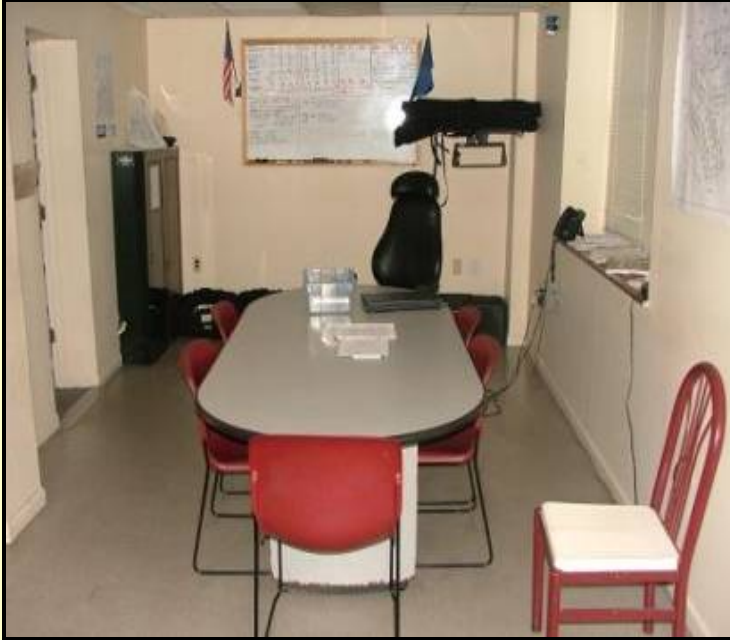
The Roll Call room is occupied by about 10-16 people at every shift change and for training. The room should be at least twice the size to meet the standard 50 square feet per person needed for such a facility (12 people @50 sq. ft. = 600.)

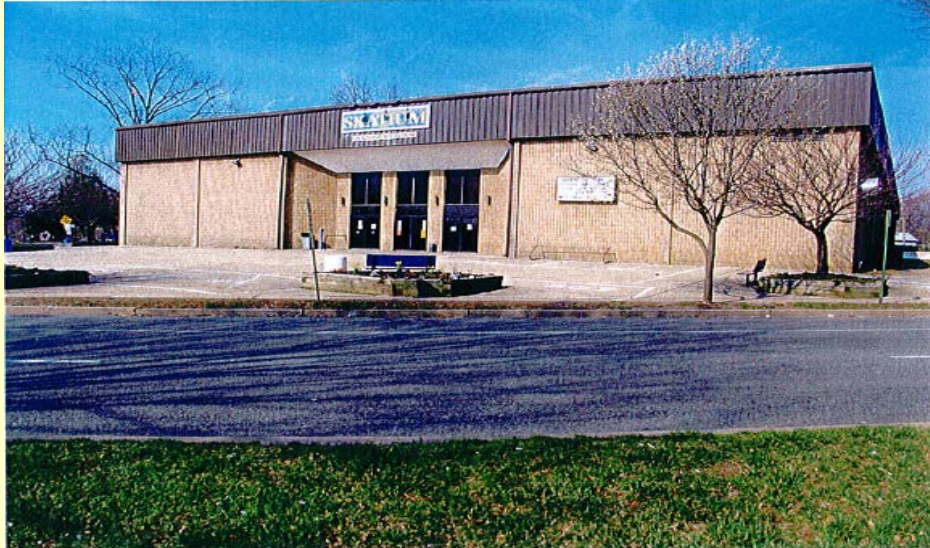
1. Skatium

The Skatium is located at 1012 Darby Road in Havertown.

In 2007, the Township commissioned Pennoni Associates to perform the Skatium Facilities Assessment Report to analyze the overall condition of the building. As a part of that report, Pennoni was asked to provide a suggested corrective action plan and affix associated costs. The roof, ice rink chillers, dehumidifier and ventilation units and cooling system all were identified for replacement. Other maintenance items listed in the report included maintenance and/or fixture placement of:

- Replace interior lighting fixtures;
- Perform electrical repairs to Panel "A" at the southwest corner of the rink;
- Remove the unused transformer in the mechanical room;
- Replace fire alarm;
- Improve public address system;
- Create fire separation between of the mechanical room;
- Upgrade the boilers for adequate hot water; and,
- Repair the control joints, steel soffits and block damage to the exterior of the building.
